Appendix D Investigation and Analysis Report

Kickapoo Creek Watershed Floodwater Retarding Structure No. 4 & 5 Investigation and Analysis Report

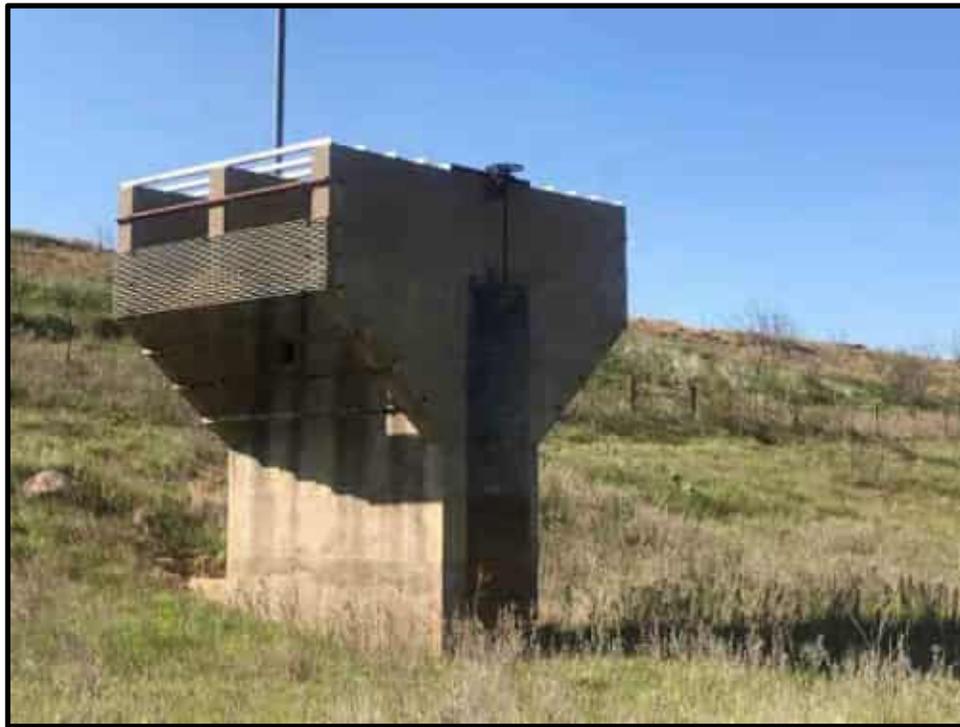
Figure 42. View of concrete intake structure, facing south

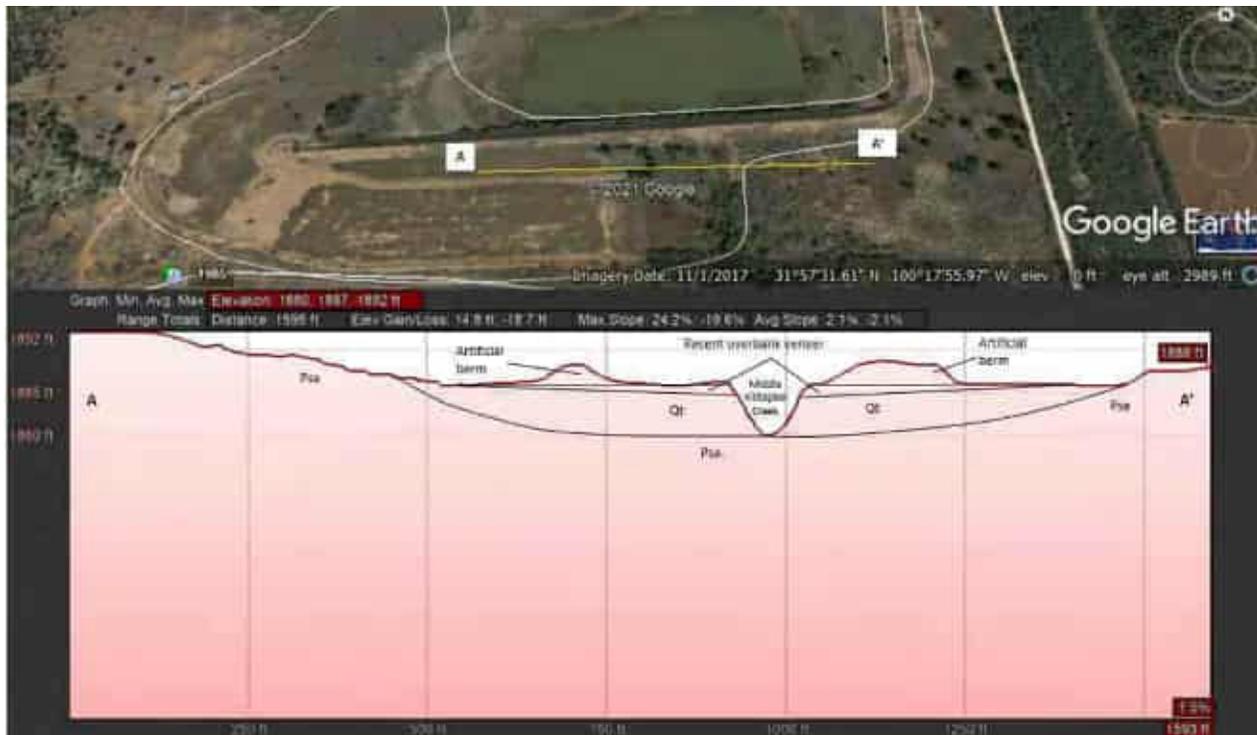
Figure 74. Stratigraphic cross section of FRS No. 5 Study Area
